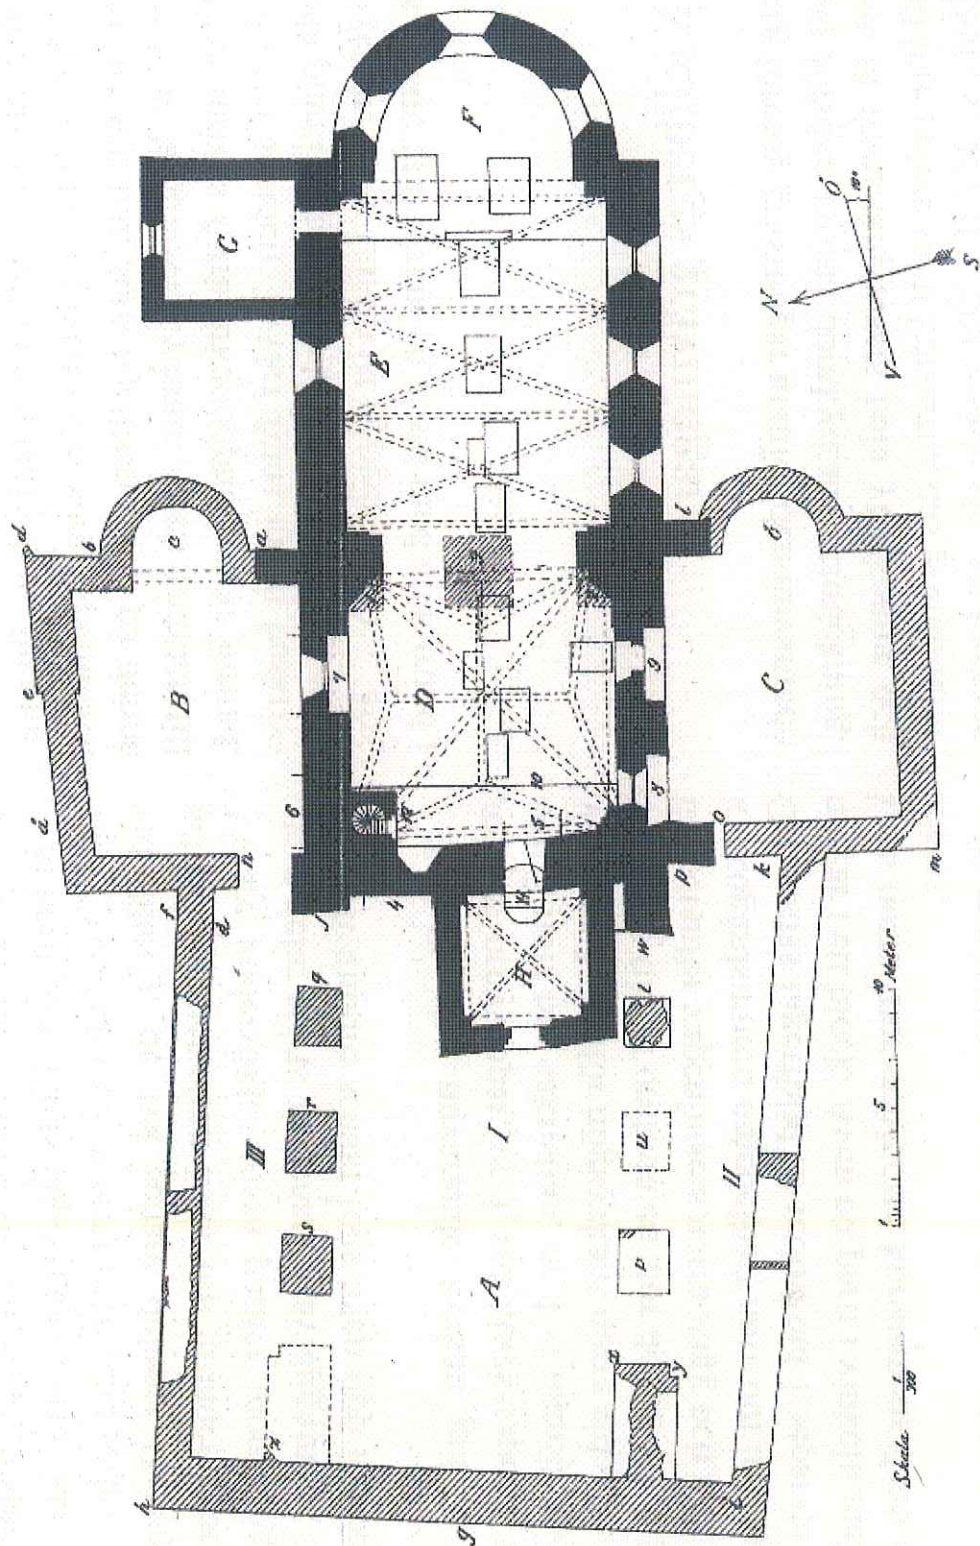
Figure 10: The cathedral excavation plan of Carl Kjellberg in 1896 (Nordahl 1996). Note the odd angle of the north transept's northern wall and the orientation of the nave.
